Lobato Trestle Bridge 339.78 Inspection and Rehabilitation Recommendations Report

August, 2010

HDR

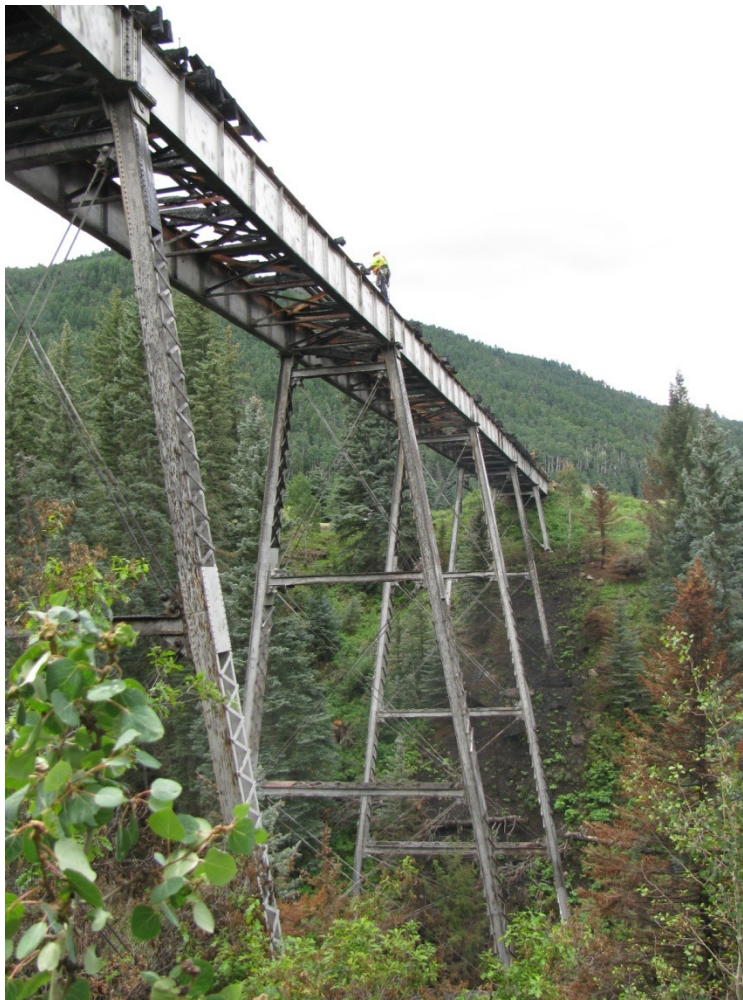
North face (left Side) of bridge Looking Timetable West toward Chama

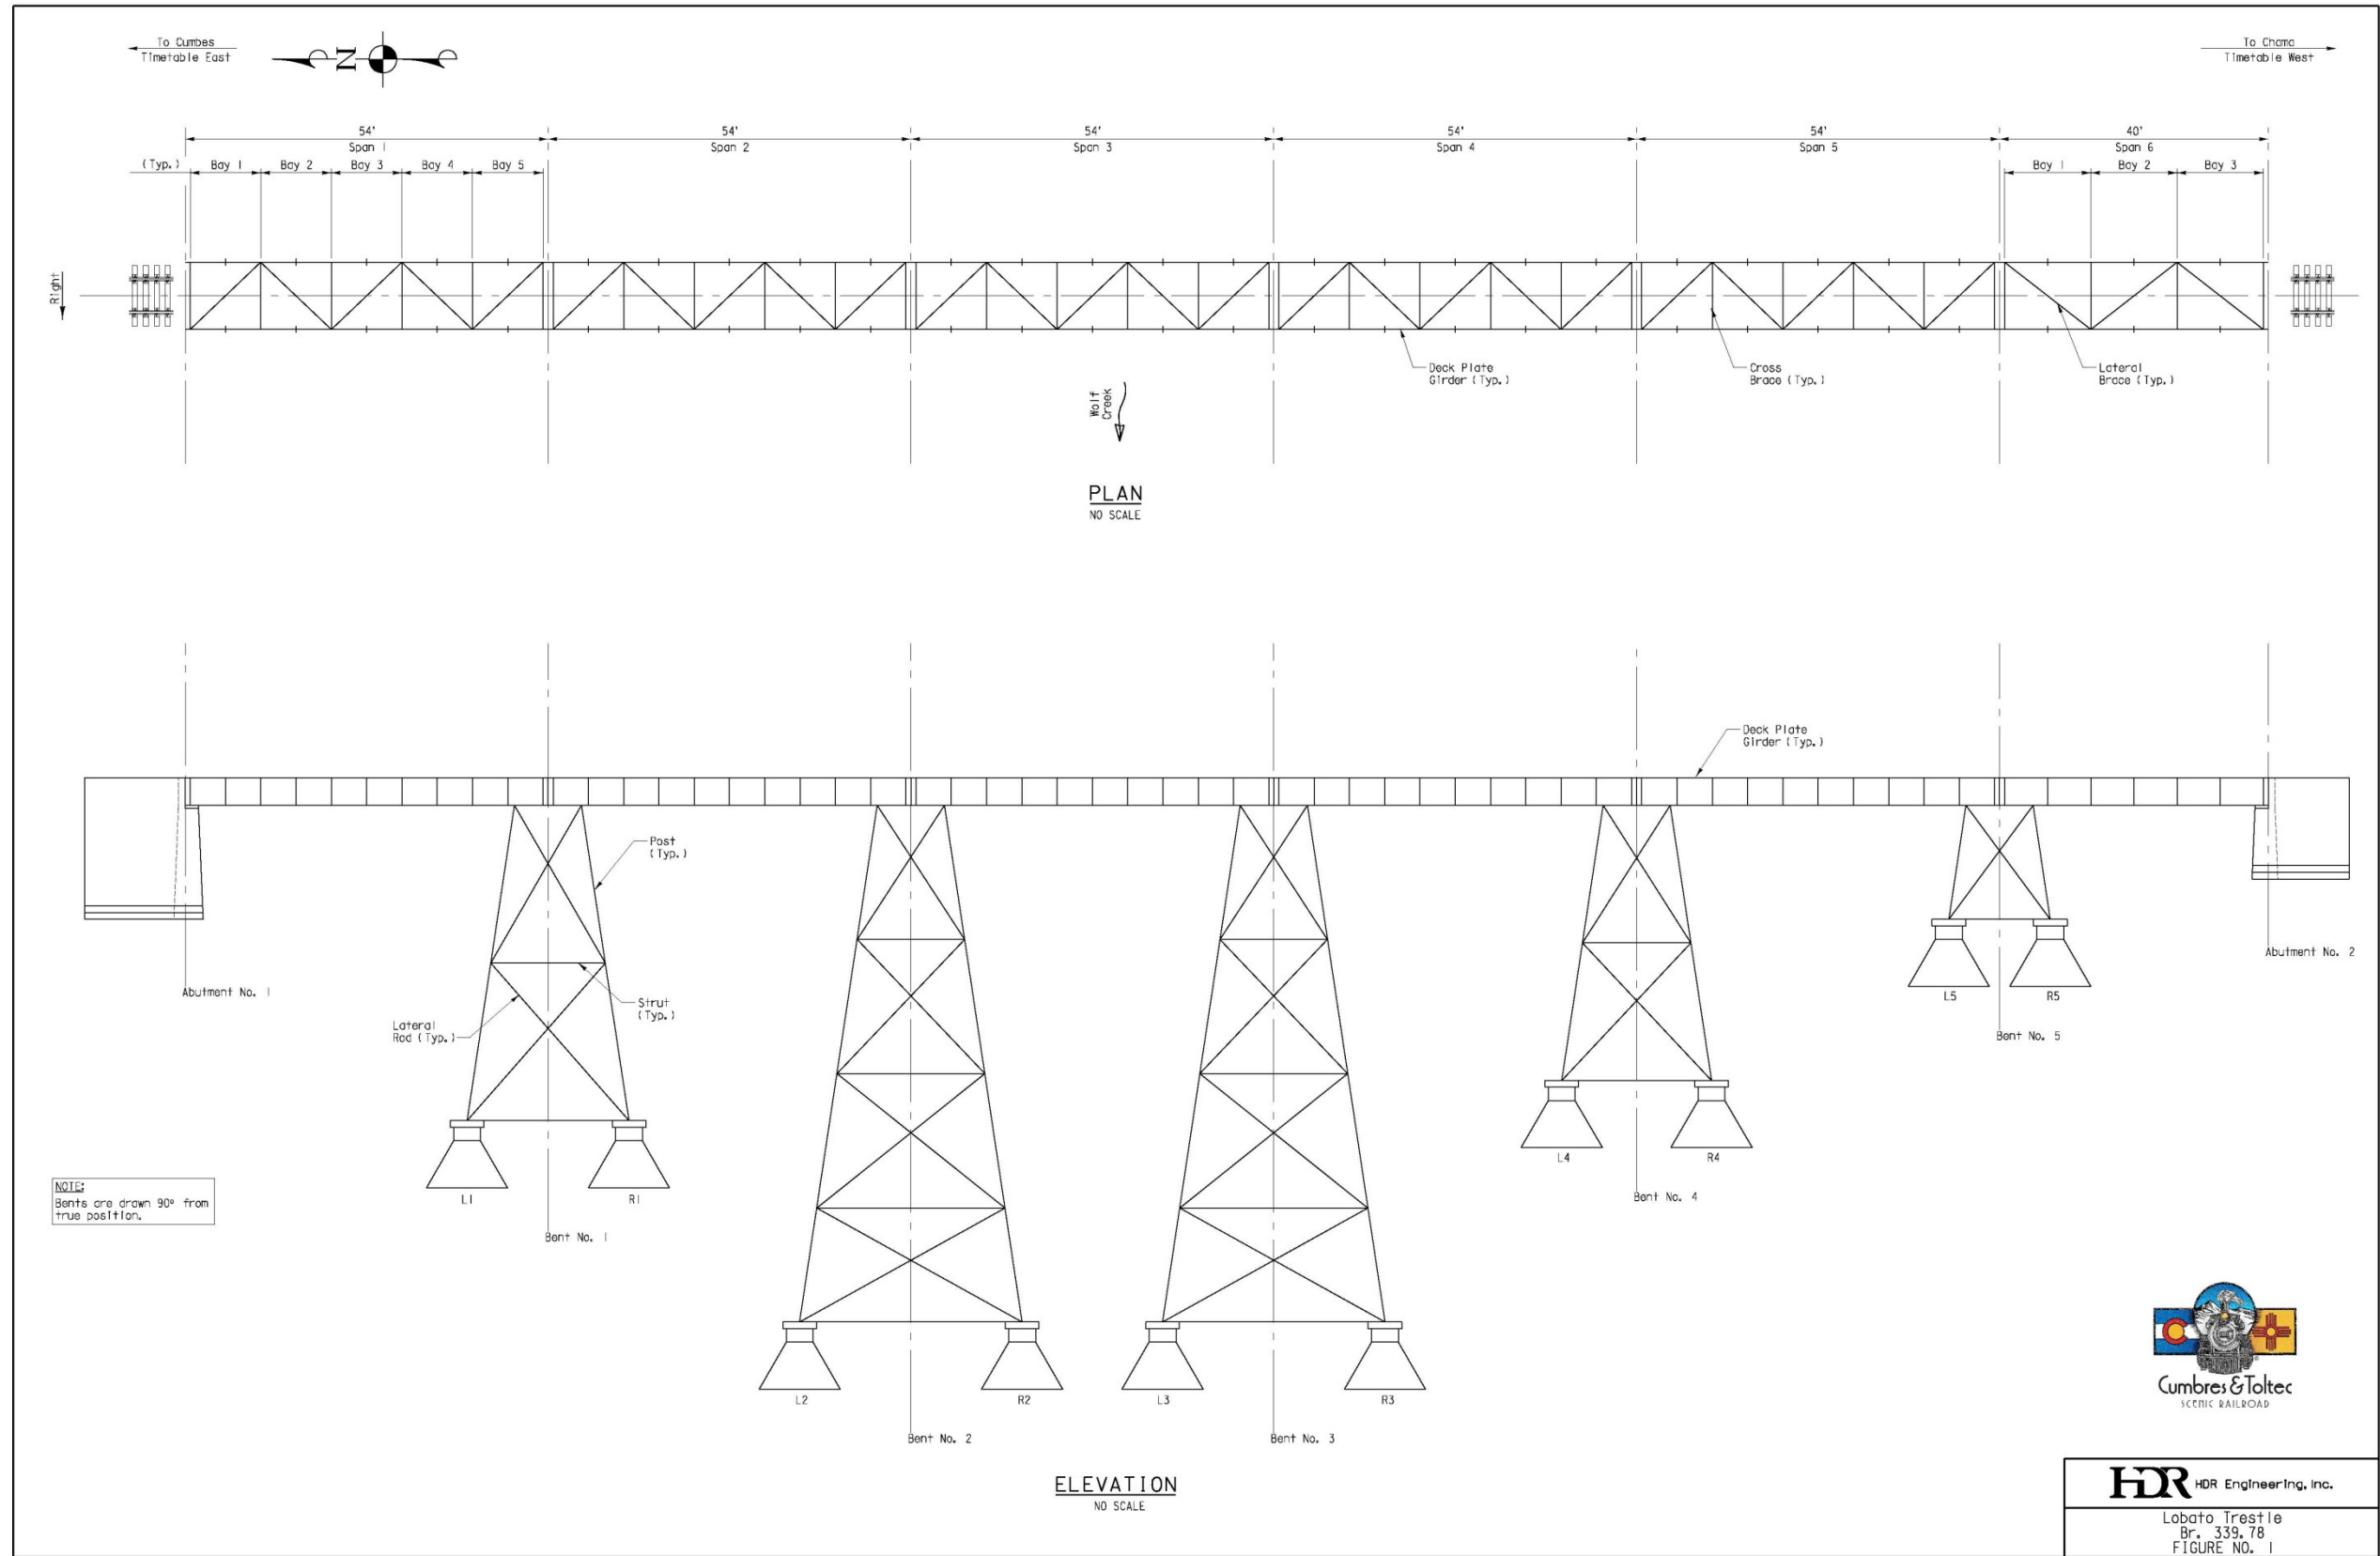
Bents and spans are numbered sequentially in the direction of increasing milepost and left to right facing in the direction of increasing milepost. (See Figure No. 1)
